From Parlor to Laboratory: A Study of the Methodology of Architectural Paint Analysis

FROM PARLOR TO LABORATORY: A STUDY OF THE METHODOLOGY OF
ARCHITECTURAL PAINT ANALYSIS

A Thesis
Presented to
the Graduate Schools of
Clemson University and the College of Charleston

by
Amanda Jane Ashburn
May 2016

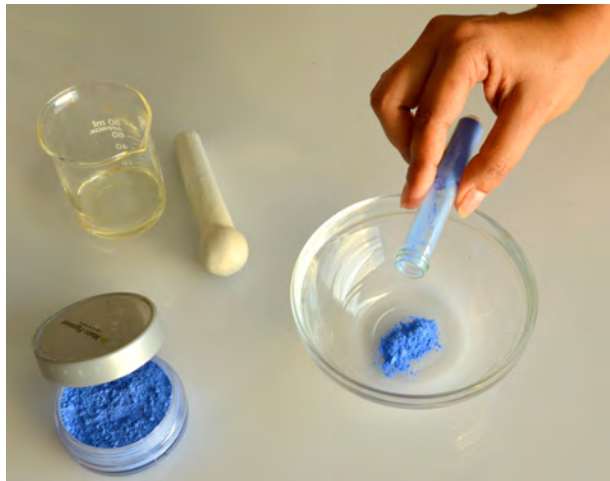
Figure 2.2 This image demonstrates the historic process of making paint. Through combining a pigment, such as Lapis Lazuli shown above, with a binder, in this case oil, the paint is created to a smooth consistency. Image property of Humaira Irfan. Sourced from the article. How to make artist's oil paints from Lapis Lazuli pigment. <http://www.demairo.org/how-to-make-artists-oil-paints-with-lapis-lazuli-pigment/>

Figure 2.2, is being mixed with an oil binder to create paint. Historically, all paints would have been mixed by hand. Today however, hand mixing of paint is limited to specialized cases, typically restoration or artistic works. The pigment in Figure 2.2, Lapis Lazuli, is costly and usually limited in application only in fine art, therefore will typically be hand mixed.

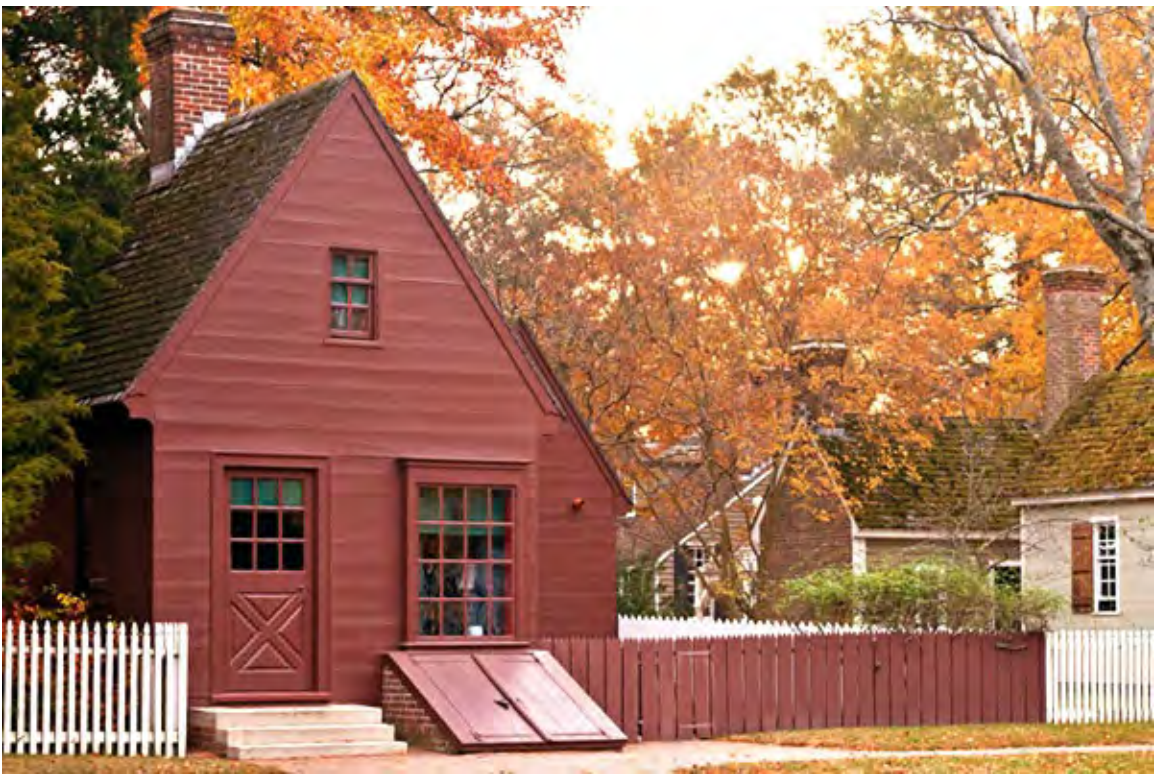
Figure 2.5 Shown above to the left of the image is the newer color scheme being used in Colonial Williamsburg after modern research found evidence suggesting that the iron oxide color, known as "Spanish Brown", was the most widely used coating in the original colonial period. Image courtesy of Colonial Williamsburg.

The entirety of Nash's work, though incredibly influential to the American expectations of historic house paints, had been proven less than accurate. Today, Colonial Williamsburg slowly works to correct paint choices as seen in Figure 2.5. The iconic imagery of rows of white homes with colorful trim is being

edited back to a more historically appropriate scheme of deep reds, muddy blacks, and faded whitewashes.¹⁷

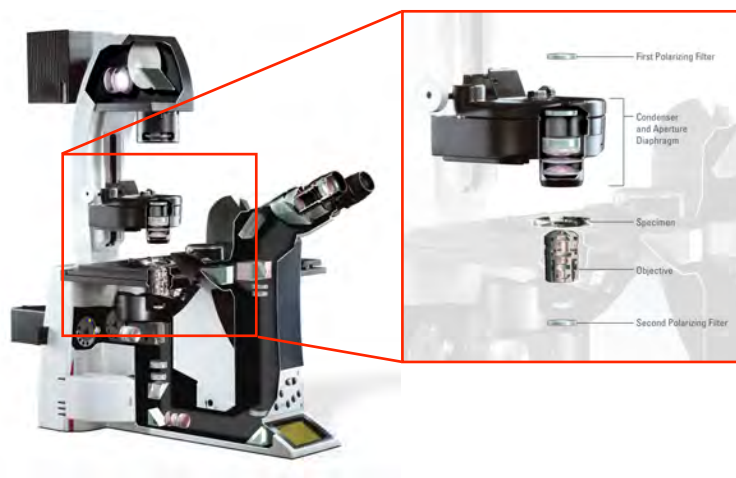
Figure 2.7 Shown above, this illustration shows the inner workings of a polarized light microscope. Image courtesy of Leica.

A polarized light microscope works by contrast-enhancing samples as they are viewed through the lens, as shown in Figure 2.7. A characteristic described as birefringence allows particles to be sorted into categories based on their refractive index. Some paint pigments are anisotropic, meaning that they will appear differently when light hits the particle in different directions.

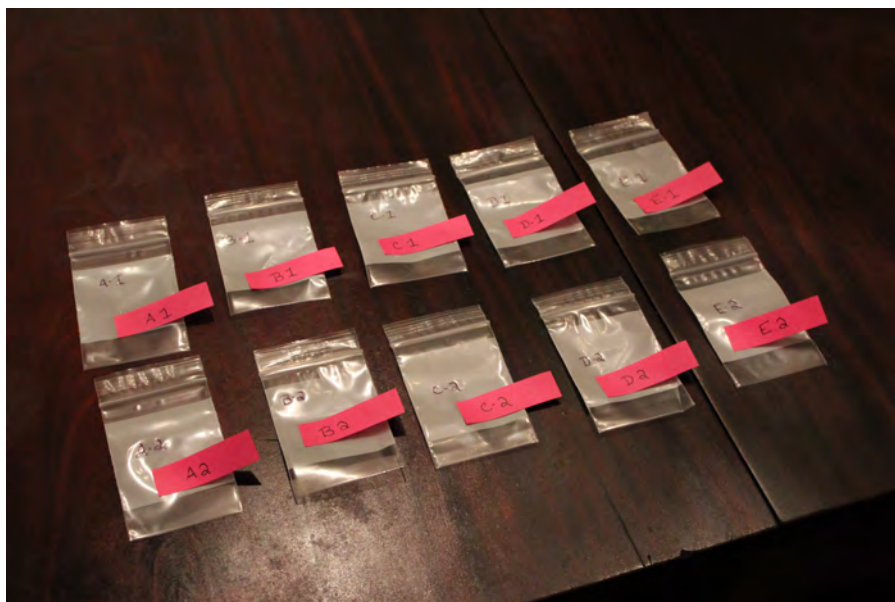
Figure 3.1 Shown above is the the authors technique of preparing for sample taking. Each baggie is pre-labeled for the intended samples and their locations. Each baggie is accompanied by a Post-it.

The documentation process used for this thesis was developed by the author as a mitigation technique for the confusion that can occur if samples are not properly labeled. Each sample area was chosen ahead of time, and each sample was heavily documented. The author chose to use Post-its as an alternative to writing upon the wall surface, which is typically accepted as an appropriate documentation technique. The Post-its were chosen due to lower risk of

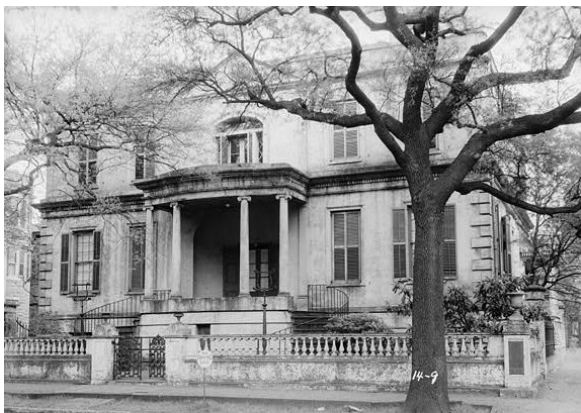
Figure 4.3 The exterior of the Owens-Thomas House. Figure 4.4 A plan view of the same house. Images: <http://www.anthemion.com>

Due perhaps to a lack of commissions, William left for America in 1817 for Savannah, Georgia. Upon his arrival, he received a commission to design a residence for his brother-in-law's sister, Frances Richardson. Shown in figures 4.3 and 4.4 the house, now known as the Owens-Thomas House of the Telfair Academy, still resides at 124 Abercorn Street, Savannah. It features a serpentine-shaped portico with an entrance niche. It was constructed using "tabby" - a mixture of lime, oyster shells, and sand similar to concrete. The exterior was finished with yellow stucco scored to appear as stone. The interior featured an elaborate plumbing system complete with running water.⁶⁰

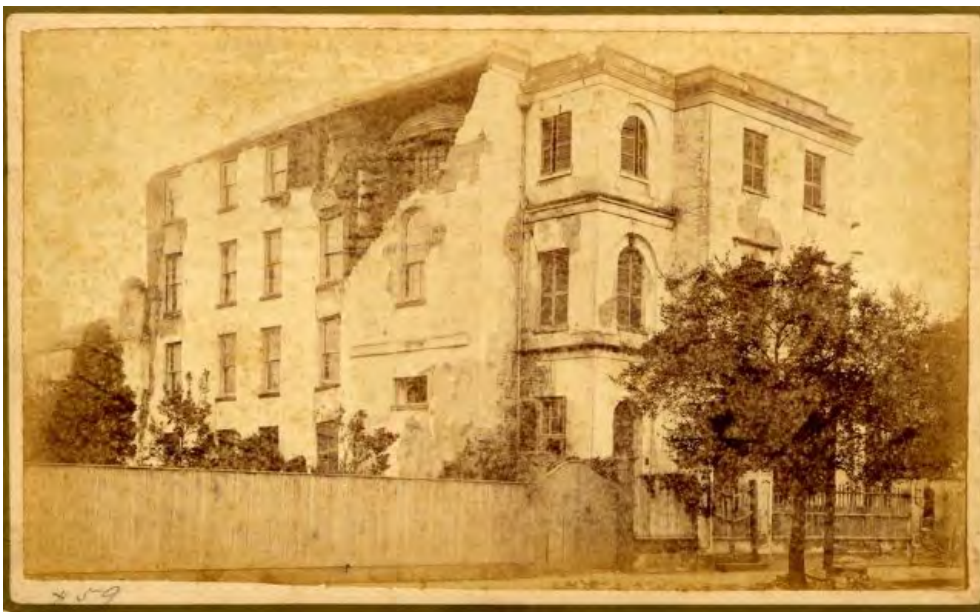
Figure 4.6 26 Meeting Street, immediately after the 1886 earthquake. Image taken by: George LaGrange Cook in 1886. Image courtesy of the Gibbes Museum of Art

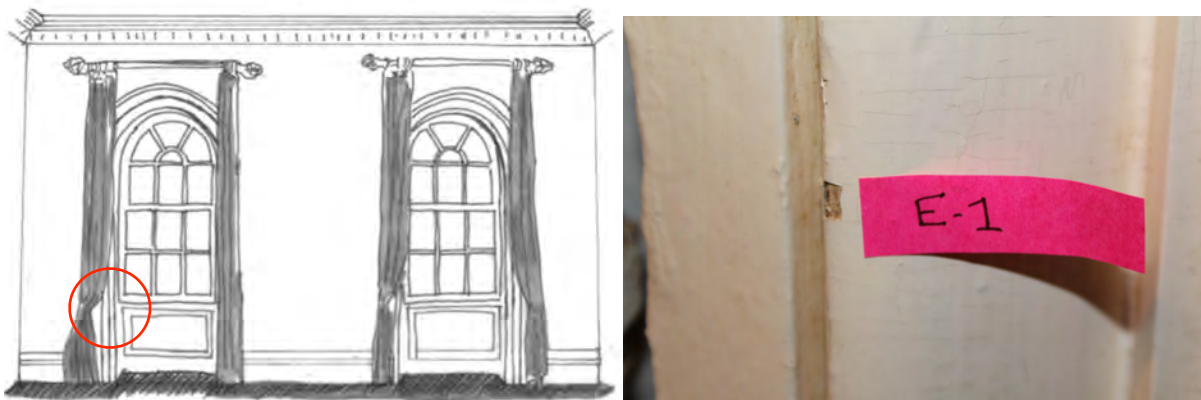
Figure 5.39 on the left; the sketch shows the location of Area E to the left of the leftmost window. Figure 5.40 on the right, the photograph documents two of the four sample locations in Area E. Illustration and photograph: J.Ashburn

The Area E samples were taken from the west wall to the left of the leftmost window, as visible in Figures 5.39 and 5.40. The E sample set was taken from a location behind large furniture in order to mitigate any negative visual impacts. Multiple samples were taken from each sample location, and four varied locations were included in Area E.

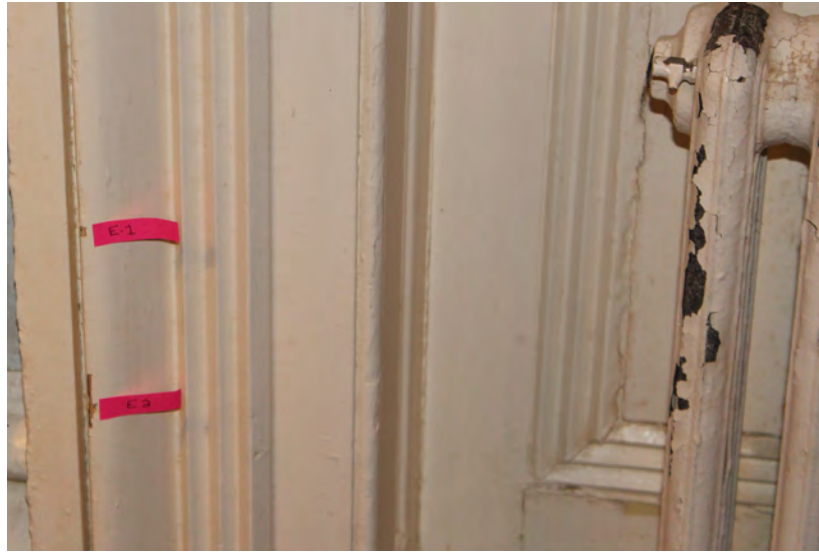
Figure 5.43 shows the two sample areas, E1 slightly higher than E2. Also visible to the right of the image is the radiator, which is experiencing paint failure as well. Image: J.Ashburn

This hypothesis of Area E surmises that the protective nature of the location, as it is located directly next to a radiator, will have allowed the area to retain original stratigraphy. This hypothesis featured a two-fold view. The location relative to the radiator does protect this area from excessive disturbance; however, the heat and moisture generated by the radiator creates areas of paint loss.

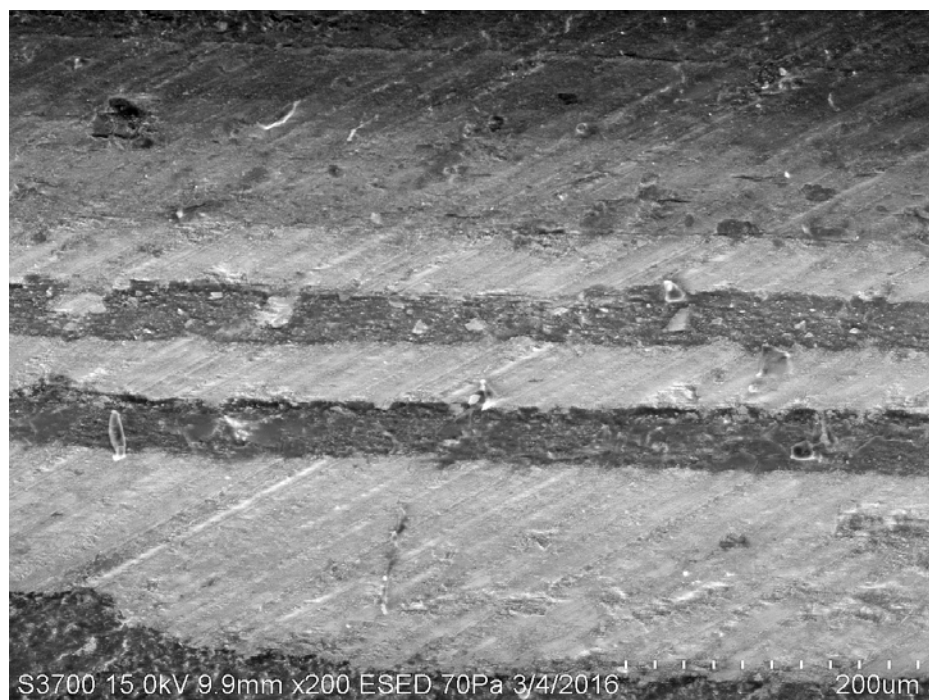
Figure 5.46 A zoomed in micrograph of the general SEM E1 Cube Sample. Image: S. Cretté, Director of the Warren Lasch Conservation Center

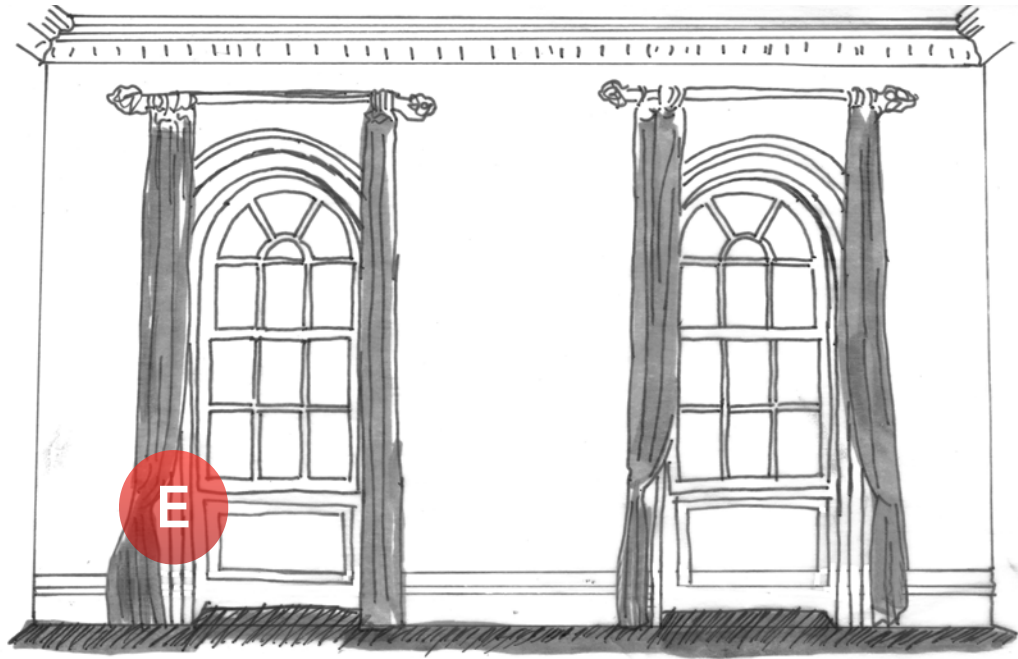
West Wall

Area E focuses on the trim-work located around the windows. This will provide a comparison to Area A.

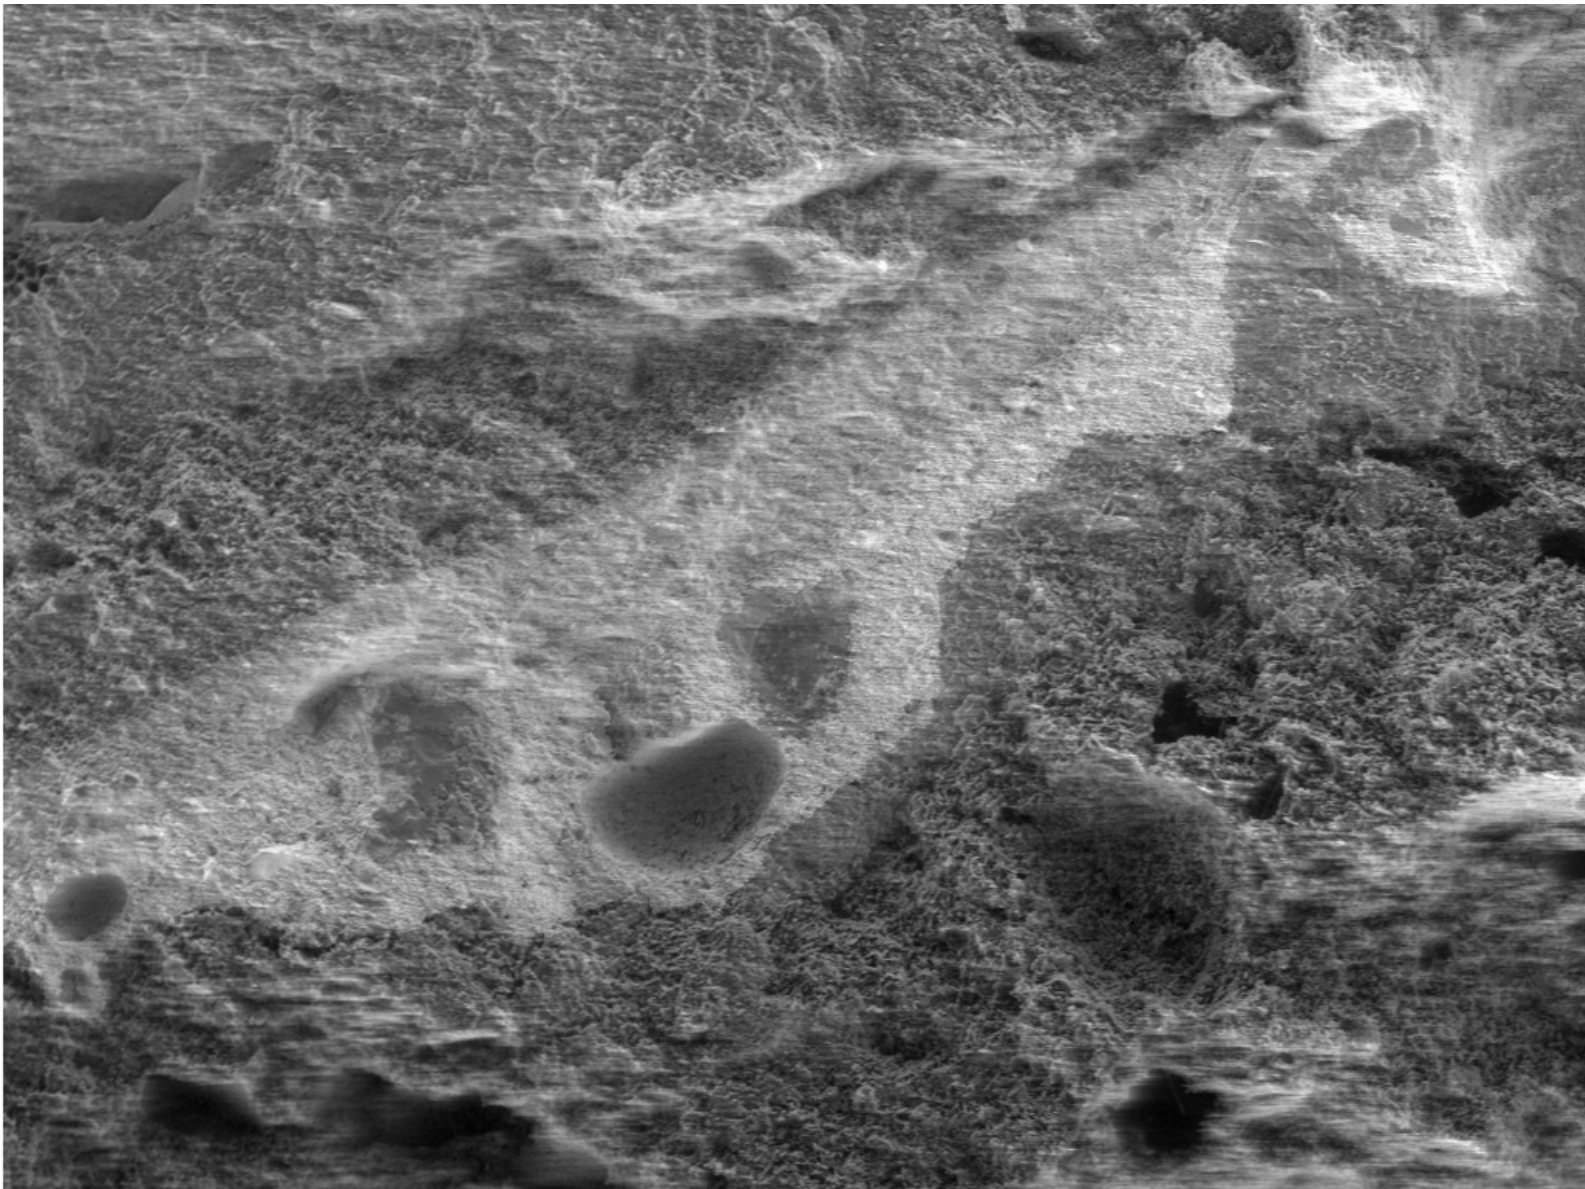
Electron Image 1

Comment: Site of Interest 5

Project: 26meeting		Sample: 26meeting A3 flake																	
Site: Site of Interest 5																			
Processing option : All elements analysed (Normalised)																			
All results in weight%																			
Spectrum	In stats.	C	O	Na	Mg	Al	Si	S	Cl	K	Ca	Ti	Cr	Fe	Zn	As	Ba	Pb	Total
Sum Spectrum	Yes	4.73	41.4	0.35	2.18	0.51	1.4	6.8	0.13	0.06	16.97	7.4	0.06	0.33	1.68	0.03	4.19	11.79	100
Mean		4.73	41.4	0.35	2.18	0.51	1.4	6.8	0.13	0.06	16.97	7.4	0.06	0.33	1.68	0.03	4.19	11.79	100
Std. deviation		0	0	0	0	0	0	0	0	0	0	0	0	0	0	0	0	0	0
Max.		4.73	41.4	0.35	2.18	0.51	1.4	6.8	0.13	0.06	16.97	7.4	0.06	0.33	1.68	0.03	4.19	11.79	
Min.		4.73	41.4	0.35	2.18	0.51	1.4	6.8	0.13	0.06	16.97	7.4	0.06	0.33	1.68	0.03	4.19	11.79
